# UNDERWATER BRIDGE INSPECTION REPORT

STRUCTURE NO. 27538

CSAH NO. 52 (HENNEPIN AVENUE)

EAST CHANNEL OF THE MISSISSIPPI RIVER

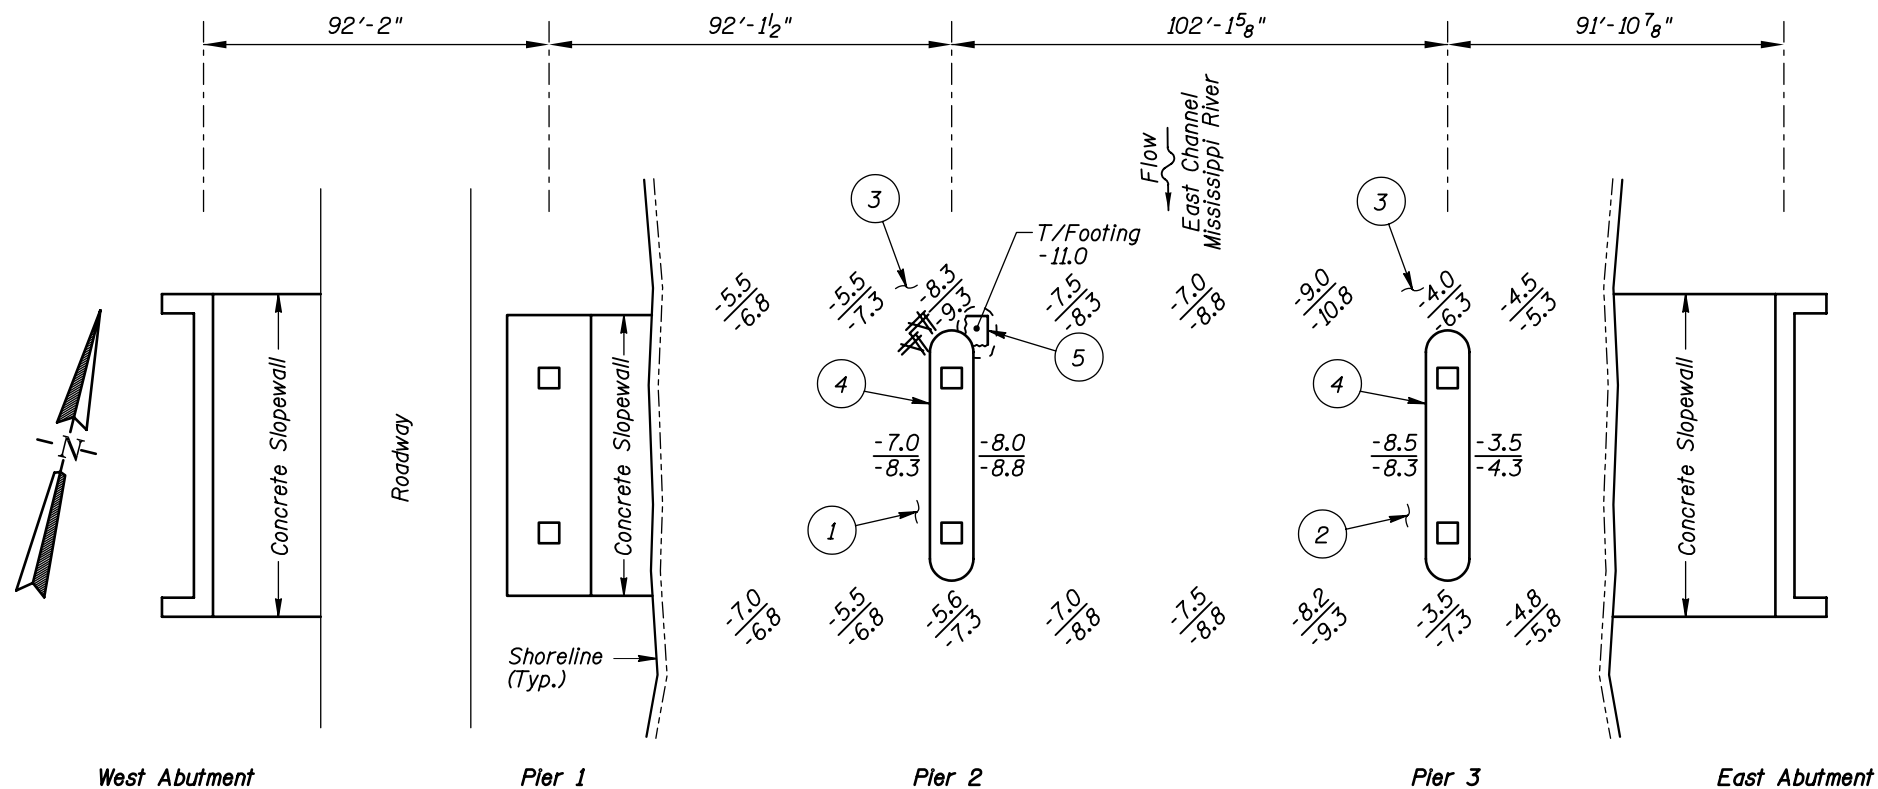
**INSPECTION AND SOUNDING PLAN**

- 1 The channel bottom material around Pier 2 consisted of silty sand with up to 1 foot of probe rode penetration.
- 2 The channel bottom material around Pier 3 consisted of silty sand with up to 1 foot of probe rode penetration and scattered riprap typically less than 1 foot in diameter except at the pier noses where the riprap was 2 to 4 feet in diameter.

- 3 Light accumulation of timber debris, mainly smaller branches, on the channel bottom at the upstream nose of the pier.
- 4 The concrete at Piers 1 and 2 was overall in good condition from the waterline to the mudline with minor scaling and a 1/8 inch layer of aquatic growth.

- 5 Scour depression that exposed a portion of the footing was observed at the upstream nose of the pier. The scour depression was approximately 6 feet in diameter and 4 feet in depth, exposing 4 feet along the horizontal face and 1 foot along the vertical face of the footing.

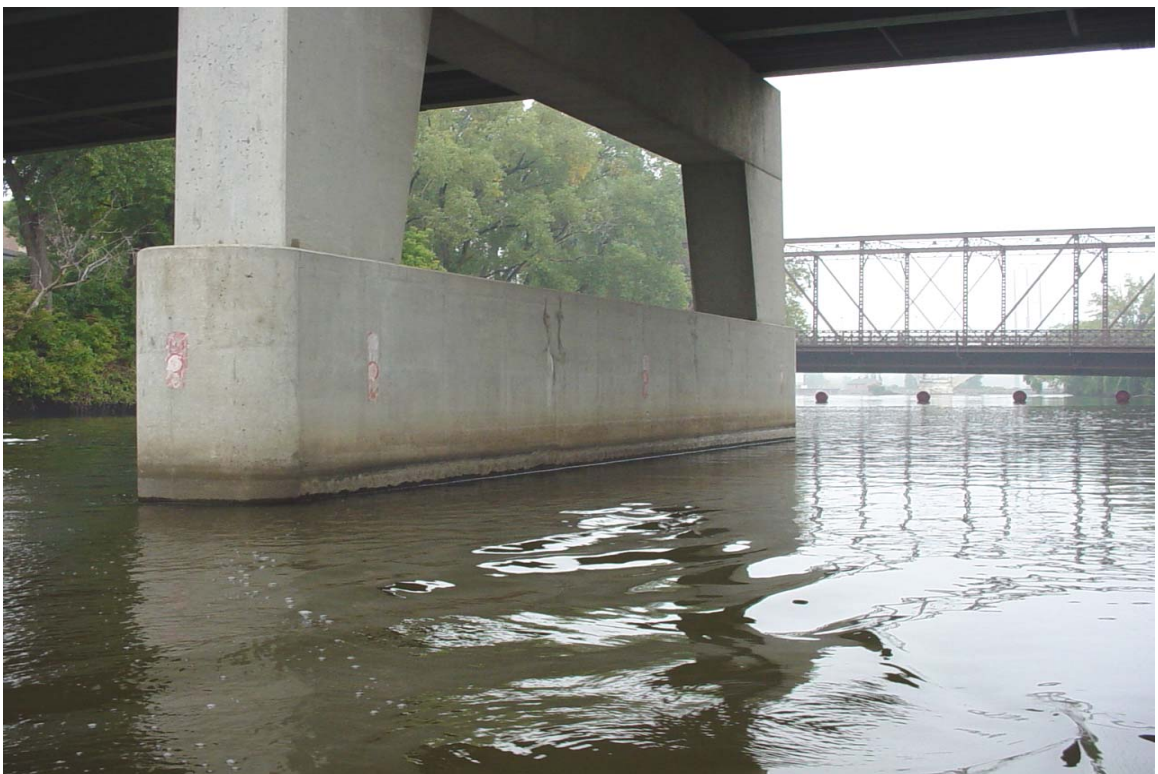
Photograph 2. View of Pier 2, Looking East.

REMARKS: Overall, the concrete piers were in good condition with no defects of structural significance observed. A light accumulation of timber debris was observed at the upstream end of Pier 2. There was a scour depression at the upstream nose of Pier 2 that has exposed a portion of the footing with up to 1 foot of vertical exposure.

Monitor the scour depression with footing exposure during future underwater inspections, and if the condition is found to be worsening, countermeasures may become warranted.

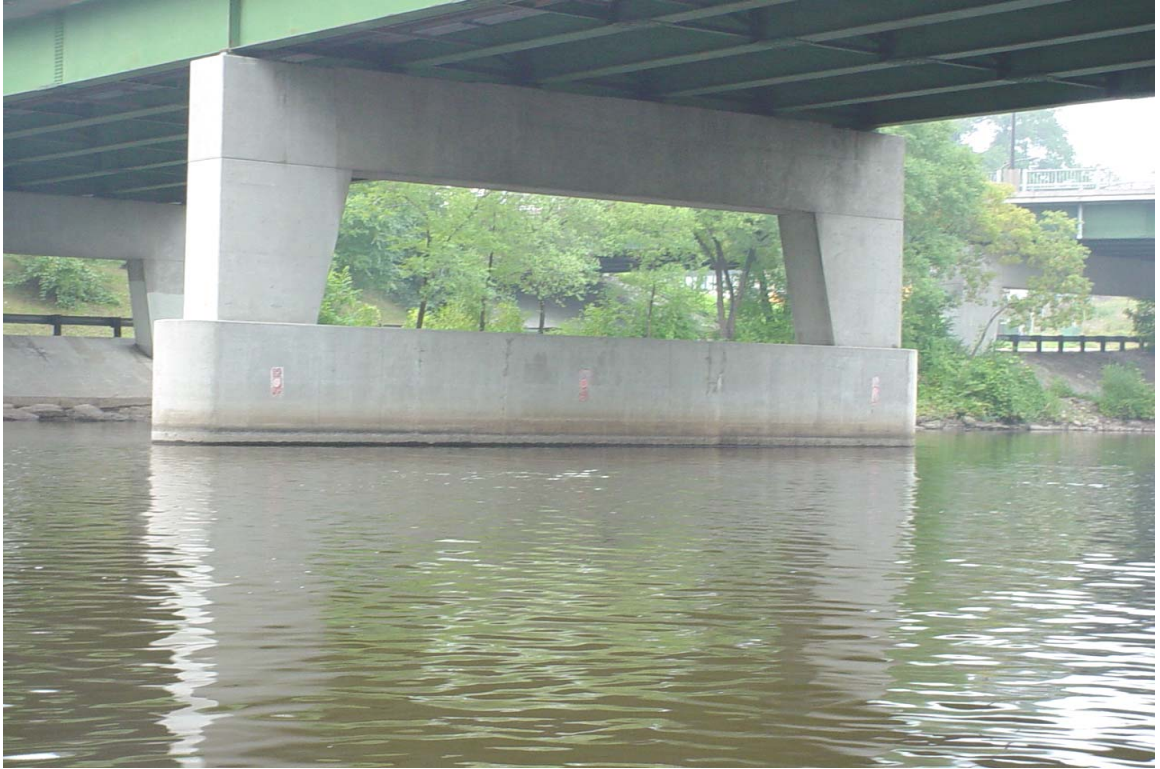
Photograph 3. View of Pier 3, Looking Southwest.
